## Open ground cracks occurred at Oya and its adjacent area, Ebina Town, Kanagawa Prefecture

海老名町大谷及び隣接地域に生じた地割れ群について

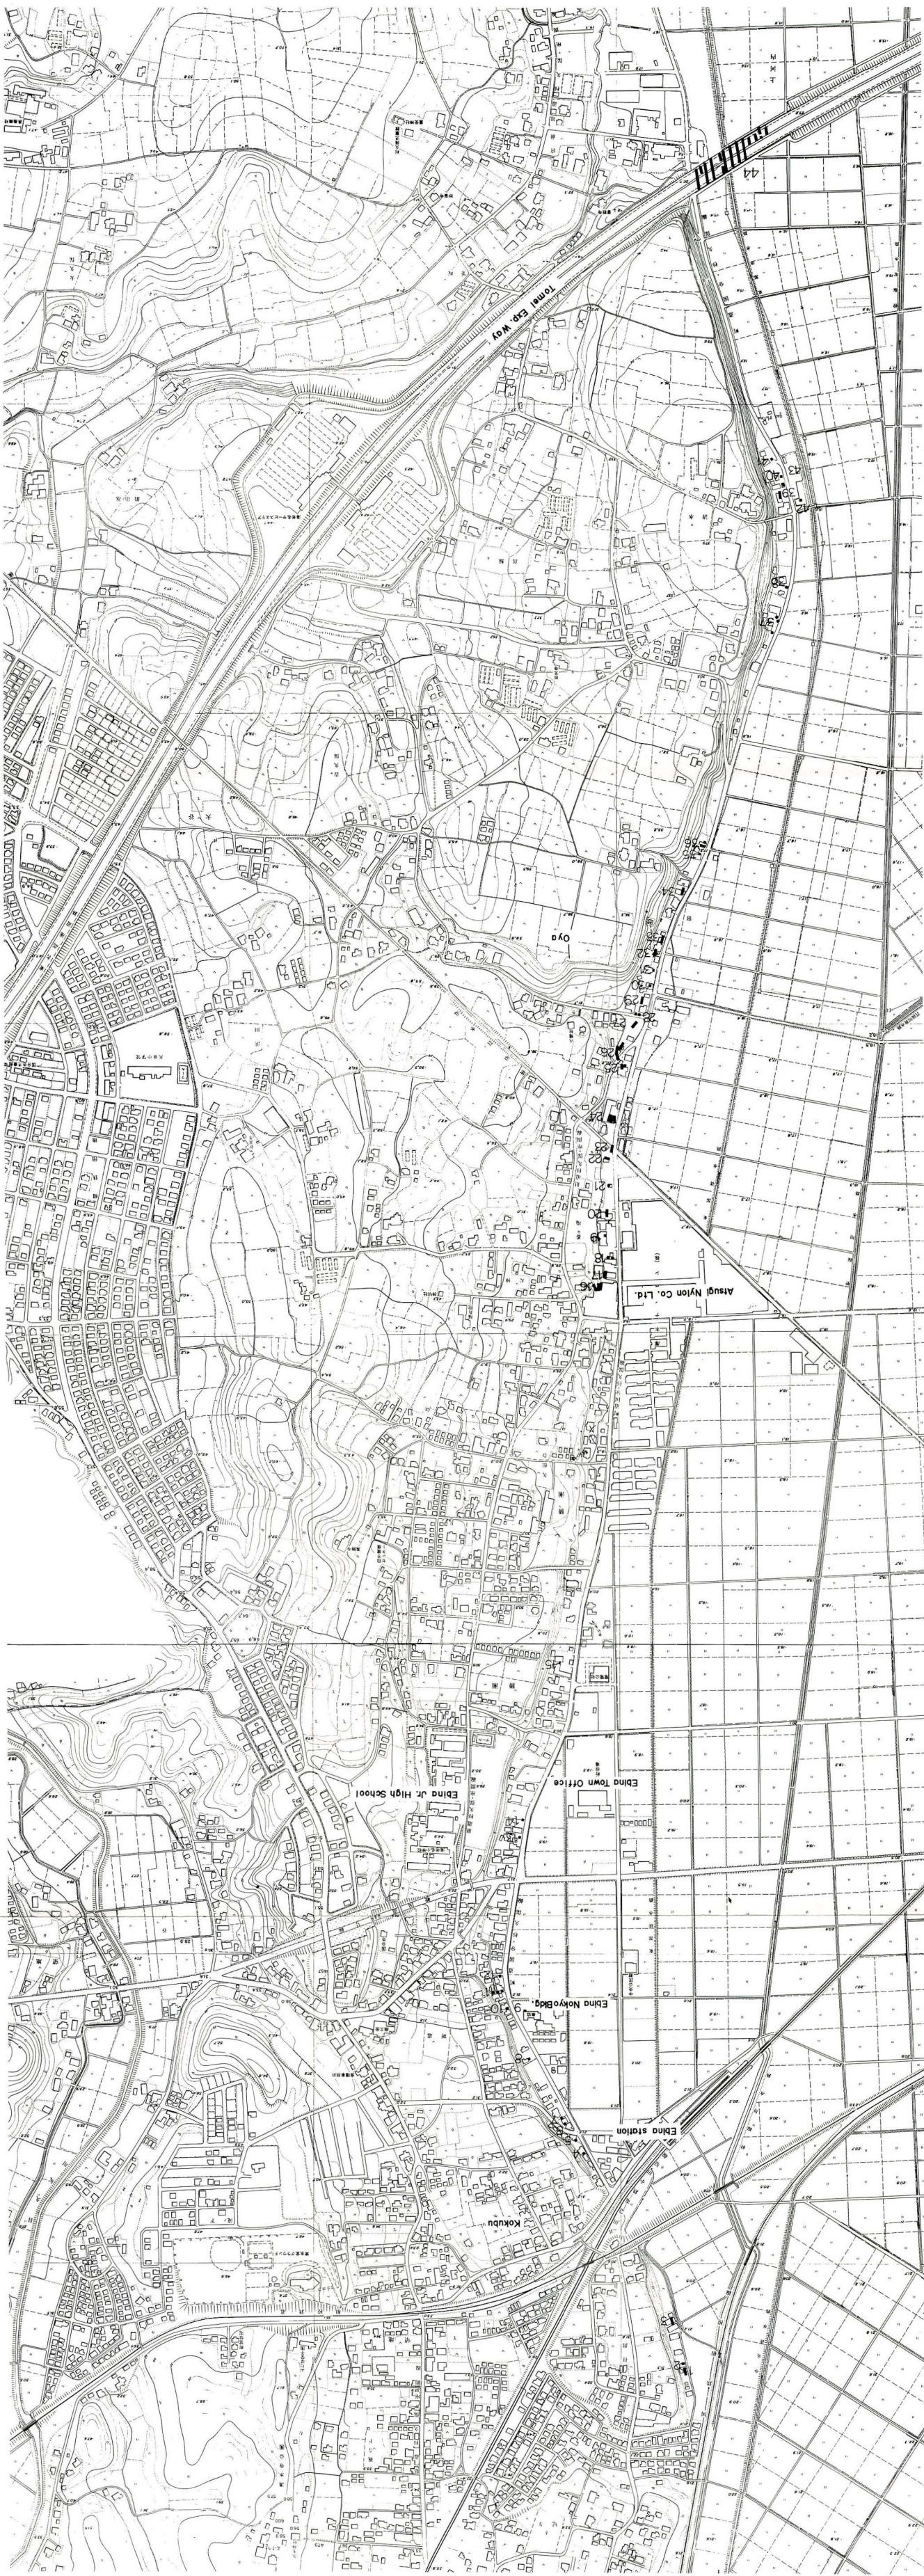
Fig. 2. Map showing the distribution of ground cracks.  
The mark indicates the crack, the mark indicates the crack  
and its direction.

The distribution of ground cracks observed by the junior writer up to August 1970 is shown in Fig. 2. The information on individual cracks, such as their

location, length, width, trend, mode of displacement, and distance from the road, Kokubu-Sugikubo Highway, running along the cliffs, have been measured at forty-four stations (Sites 1 to 44, Fig. 2), the results of which are listed in Table 1. Below is given some additional descriptions of them.

- 1) The cracks are limited in distribution to a narrow area between the back swamp and the foot of the cliff, and arranged intermittently in a fissure zone extending from north to south along the foot. And also they are concentrated in the middle and the southern parts of this zone where the villages of Oya and Shimizu are located.

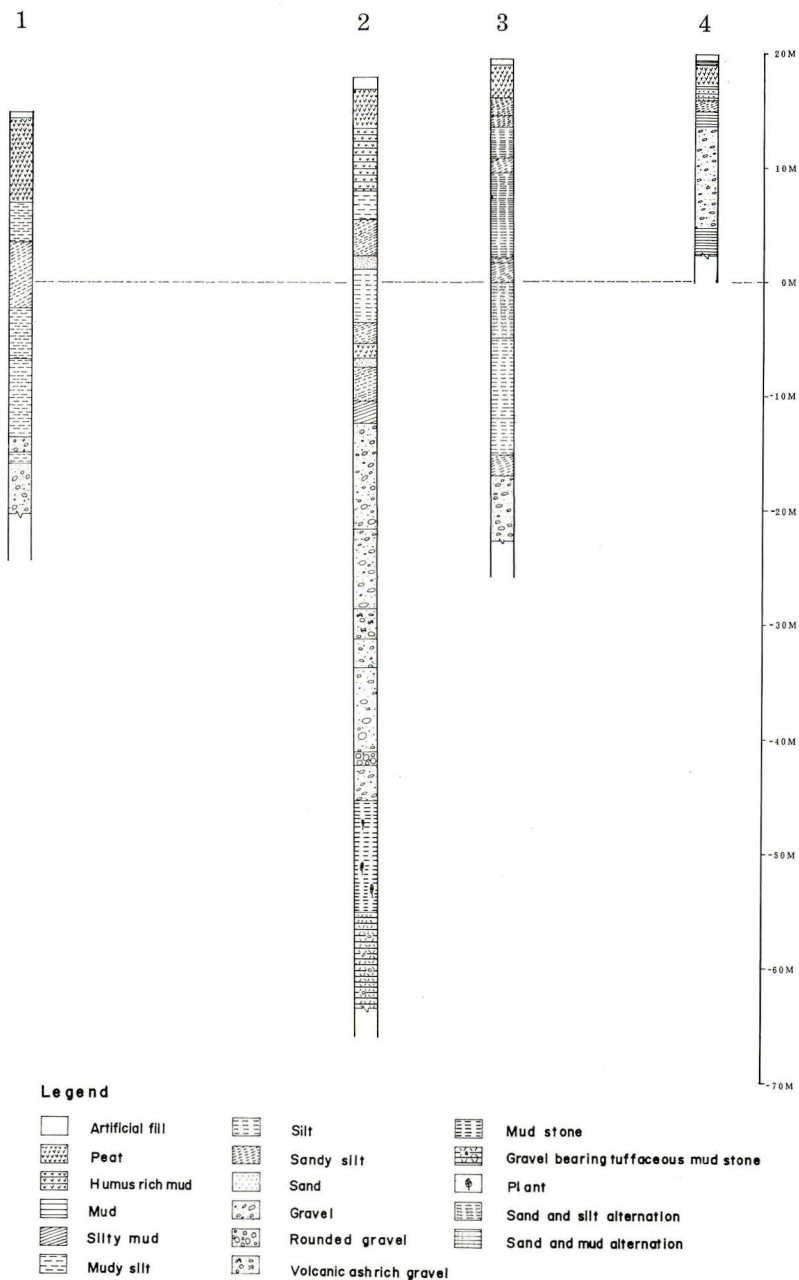
Fig. 3. Columnar section of the back swamp.

The back swamp consists mainly of humic soils and soft, unconsolidated muddy sediments overlying a gravel bed more than 30 m thick (Fig. 3).

1. Tomei Exp. Way (about 50 m from the foot of cliff)
2. Test Bore Point      3. Atsugi Nylon Co., LTD.
4. Ebina Town Office

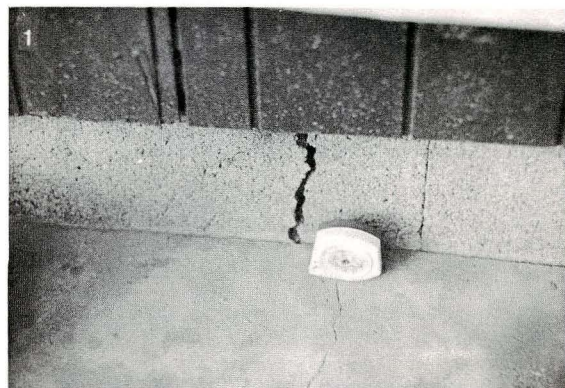
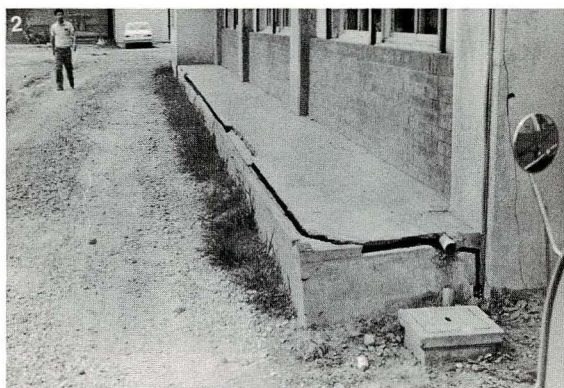
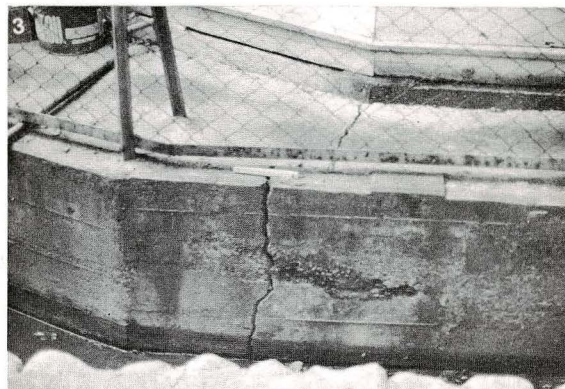
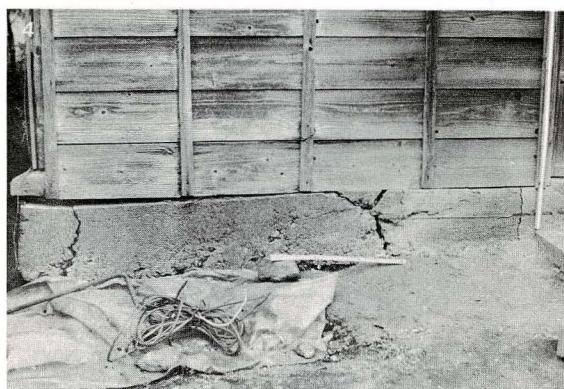
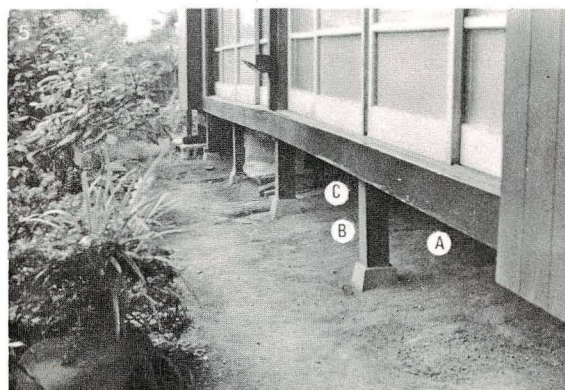
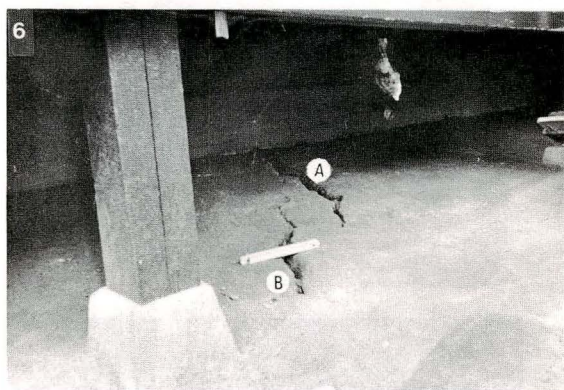
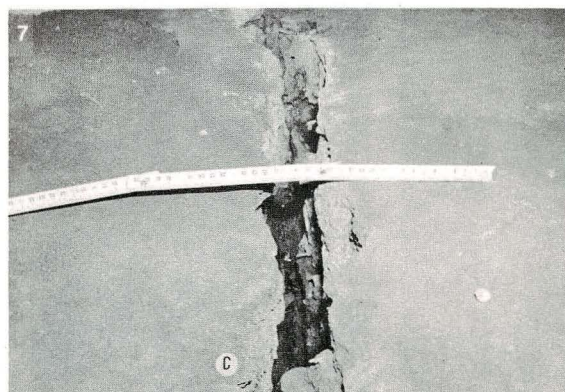
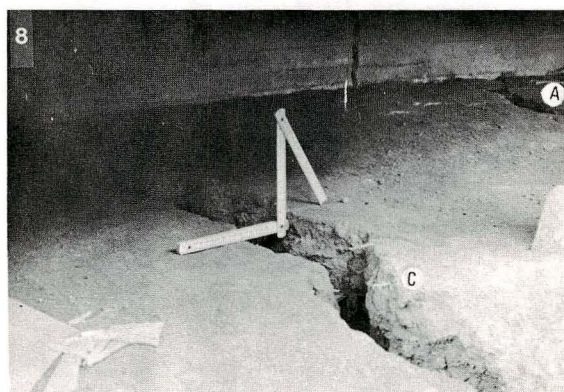
## Plate 22

The crack at Site 9 is opened on a concrete floor extruding from the Ebina Nokyo Building situated on the soil-covered back swamp, and the result of measurement shows this floor declining 7 cm at its end, without any appreciable lateral displacement (Pl. 22, Fig. 2).

The three cracks at Site 24 are observed under a veranda of a house, and arranged in parallel at the intervals of several meters. And they are also associated with several small cracks trending in the almost same direction. Of these cracks, the middle one is opened 7 cm in maximum separation, and its west side is vertically downthrown, the amount of which attains to 3 cm (Pl. 22, Figs. 5, 7 and 8).

- Fig. 1 A crack occurred on a concrete base, looking northward at Site 1.
- Fig. 2 A crack opened on a concrete floor of Ebina Nokyo Bldg., looking westward at Site 9. Relative subsidence of the floor amounts to 7 cm.
- Fig. 3 A crack seen on a concrete paving of Atsugi Nylon Co., looking northward at Site 16.
- Fig. 4 Crack traversing a concrete base, looking northward at Site 23.  
The base is cracked at three points and downthrown in the west.
- Fig. 5 Three ground cracks-A, B and C-under a veranda of a wooden house, looking westward at Site 24. Note that western half of the house is subsided and bent.
- Fig. 6 Enlarged photograph of the cracks A and B in Fig. 5 looking northward. They are arranged in echelon.
- Fig. 7 Enlarged photograph of the crack C in Fig. 5 looking northward. West side of the crack is downthrown vertically.
- Fig. 8 Ditto.

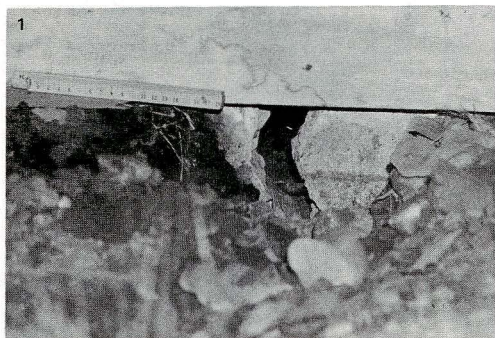
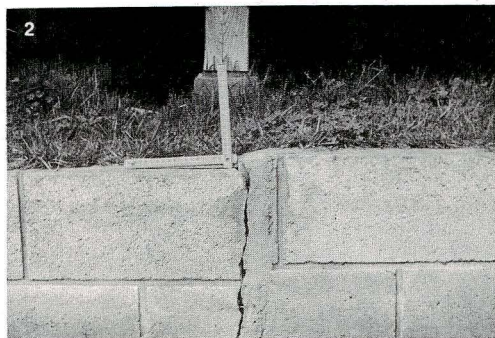
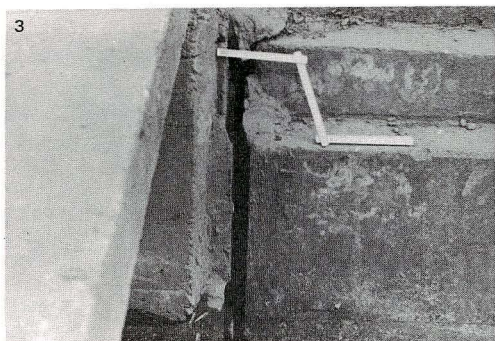
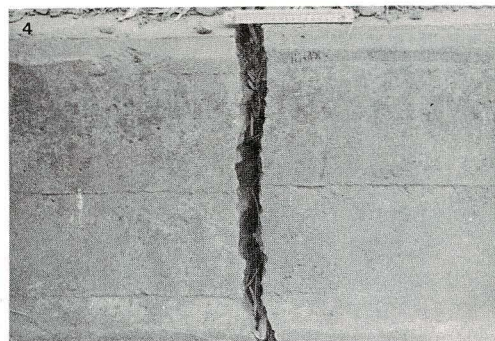
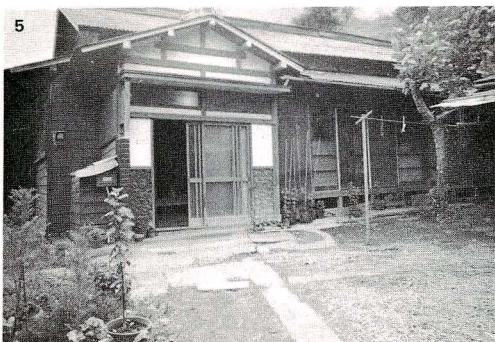
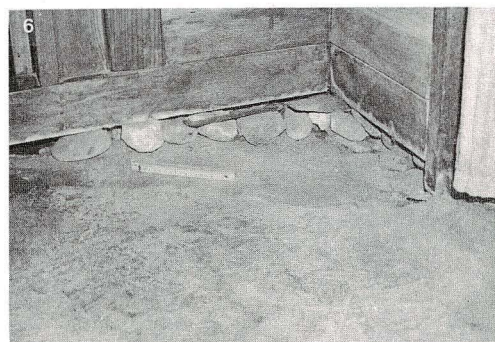
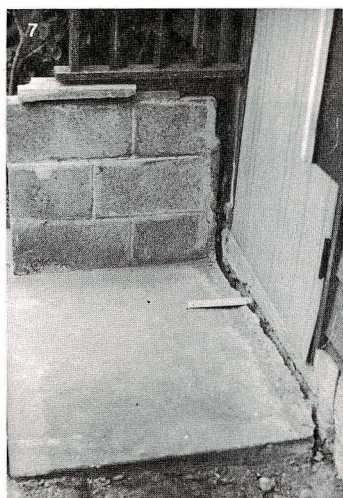
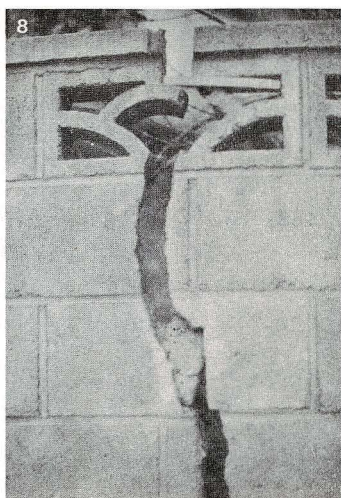
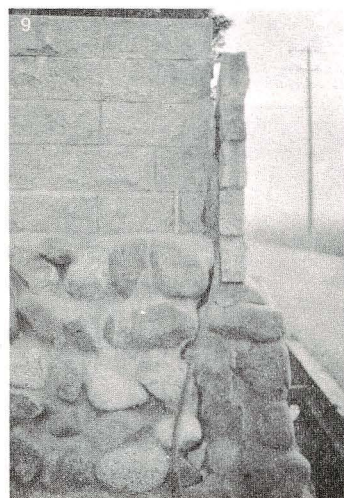
## Plate 23

One of the three cracks at Site 25 is seen traversing a concrete base of a wooden house, and is estimated 4.5 cm in maximum separation. The other two are observed on a concrete block wall several meters to the south of the house. Both trending in a N-S direction reveal clearly vertical displacement amounting to 3.5 cm and 0.5 cm respectively, and their downthrown sides are in the west (Pl. 23, Figs. 1 and 2).

One of the three cracks at Site 37 is of special interest in its mode of displacement. This crack runs across the north side of a concrete block-wall trending in a E-W direction, and its west side is downthrown by about 15 cm and displaced laterally by 7 cm to the north.

- Fig. 1 A crack crossing a concrete base, looking northward at Site 25.  
The separation amounts to 4.5 cm.
- Fig. 2 A crack running across a concrete block wall, looking northward at Site 25. This shows clearly vertical displacement.

- Fig. 3 A crack traversing a water-way made of concrete, looking southward at Site 28.
- Fig. 4 A crack traversing a water-way made of concrete, looking southward at Site 28. 5 meter east of the crack in Fig. 3.

- Fig. 5 A stoop downthrown on the west, looking northward at Site 35.
- Fig. 6 A foundation of subsided poach at Site 35. Note that stones are inserted for sustaining the flame wood.

- Fig. 7 Photograph showing a concrete floor separated from a concrete base, looking northward at Site 31. Note that the floor tilted westward.
- Fig. 8 A crack crossing obliquely a concrete block wall, looking north-eastward at Site 37.

- Fig. 9 A crack at the northern corner of concrete block wall which surrounds the dwelling, looking southward at Site 38. The amount of vertical displacement attains to 20 cm.
