Open ground cracks occurred at Oya and its adjacent area, Ebina Town, Kanagawa Prefecture

Keizo MIKAMI* & Isamu IMANAGA

海老名町大谷及び隣接地域に生じた地割れ群について

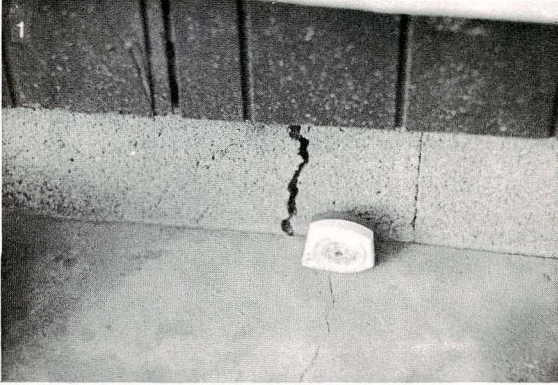
- Fig. 1 A crack occurred on a concrete base, looking northward at Site 1.
- Fig. 2 A crack opened on a concrete floor of Ebina Nokyo Bldg., looking westward at Site 9. Relative subsidence of the floor amounts to 7 cm.
- Fig. 3 A crack seen on a concrete paving of Atsugi Nylon Co., looking northward at Site 16.
- Fig. 4 Crack traversing a concrete base, looking northward at Site 23. The base is cracked at three points and downthrown in the west.
- Fig. 5 Three ground cracks—A, B and C—under a veranda of a wooden house, looking westward at Site 24. Note that western half of the house is subsided and bent.
- Fig. 6 Enlarged photograph of the cracks A and B in Fig. 5 looking northward. They are arranged in echelon.
- Fig. 7 Enlarged photograph of the crack C in Fig. 5 looking northward. West side of the crack is downthrown vertically.
- Fig. 8 Ditto.

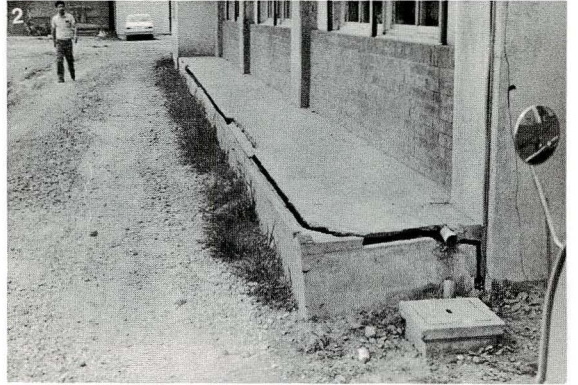
The crack at Site 9 is opened on a concrete floor extruding from the Ebina Nokyo Building situated on the soil-covered back swamp, and the result of measurement shows this floor declining 7 cm at its end, without any appreciable lateral displacement (Pl. 22, Fig. 2).

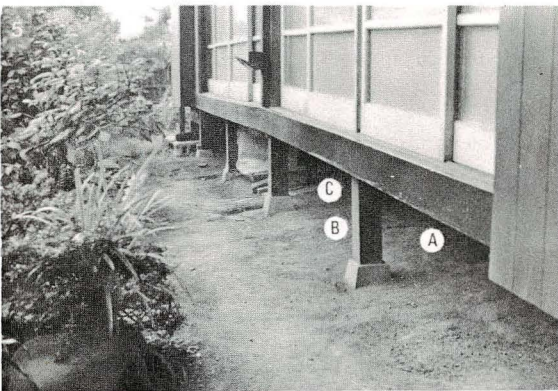
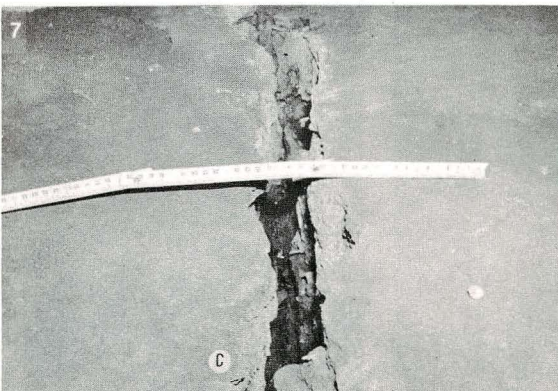
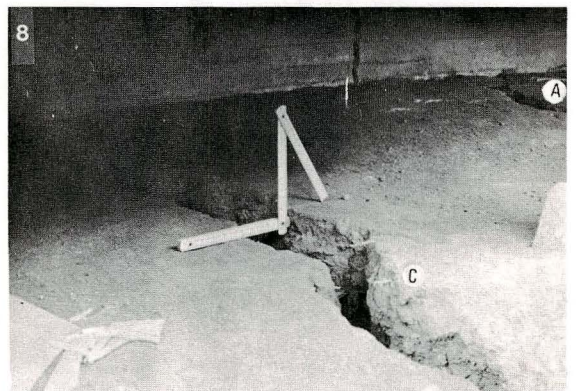
The three cracks at Site 24 are observed under a veranda of a house, and arranged in parallel at the intervals of several meters. And they are also associated with several small cracks trending in the almost same direction. Of these cracks, the middle one is opened 7 cm in maximum separation, and its west side is vertically downthrown, the amount of which attains to 3 cm (Pl. 22, Figs. 5, 7 and 8).

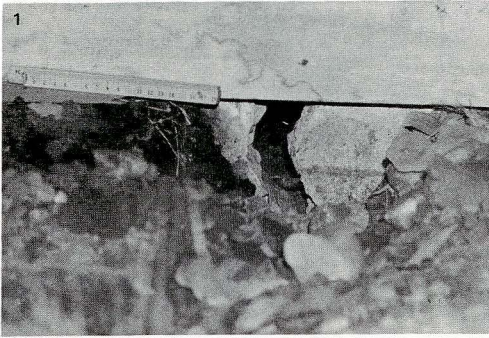
One of the three cracks at Site 25 is seen traversing a concrete base of a wooden house, and is estimated 4.5 cm in maximum separation. The other two are observed on a concrete block wall several meters to the south of the house. Both trending in a N-S direction reveal clearly vertical displacement amounting to 3.5 cm and 0.5 cm respectively, and their downthrown sides are in the west (Pl. 23, Figs. 1 and 2).

- Fig. 1 A crack crossing a concrete base, looking northward at Site 25. The separation amounts to 4.5 cm.
- Fig. 2 A crack running across a concrete block wall, looking northward at Site 25. This shows clearly vertical displacement.

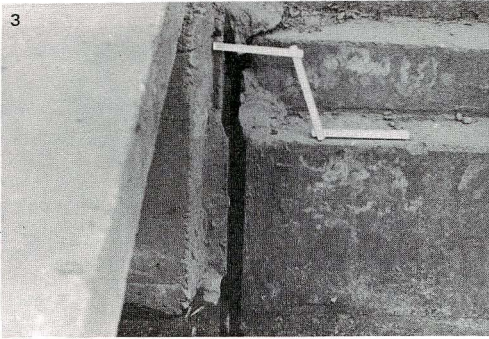
- Fig. 3 A crack traversing a water-way made of concrete, looking southward at Site 28.
- Fig. 4 A crack traversing a water-way made of concrete, looking southward at Site 28. 5 meter east of the crack in Fig. 3.

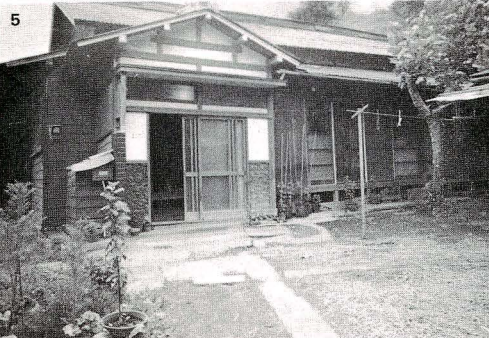
- Fig. 5 A stoop downthrown on the west, looking northward at Site 35.
- Fig. 6 A foundation of subsided poach at Site 35. Note that stones are inserted for sustaining the flame wood.

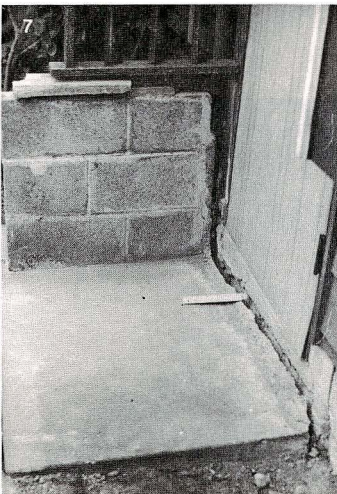
- Fig. 7 Photograph showing a concrete floor separated from a concrete base, looking northward at Site 31. Note that the floor tilted westward.
- Fig. 8 A crack crossing obliquely a concrete block wall, looking north-eastward at Site 37.

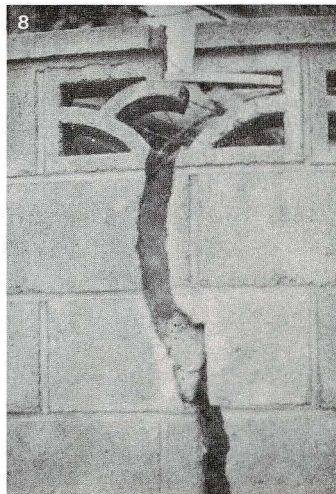
One of the three cracks at Site 37 is of special interest in its mode of displacement. This crack runs across the north side of a concrete block-wall trending in a E-W direction, and its west side is downthrown by about 15 cm and displaced laterally by 7 cm to the north.

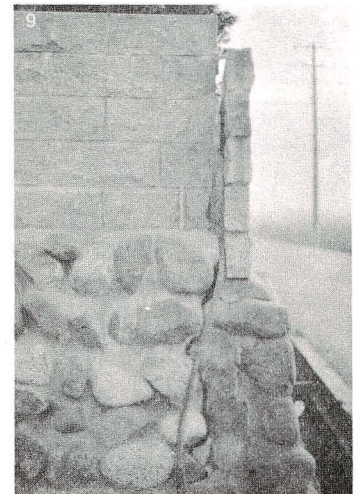
- Fig. 9 A crack at the northern corner of concrete block wall which surrounds the dwelling, looking southward at Site 38. The amount of vertical displacement attains to 20 cm.
