Open ground cracks occurred at Oya and its adjacent area, Ebina Town, Kanagawa Prefecture

Keizo MIKAMI* & Isamu IMANAGA

海老名町大谷及び隣接地域に生じた地割れ群について

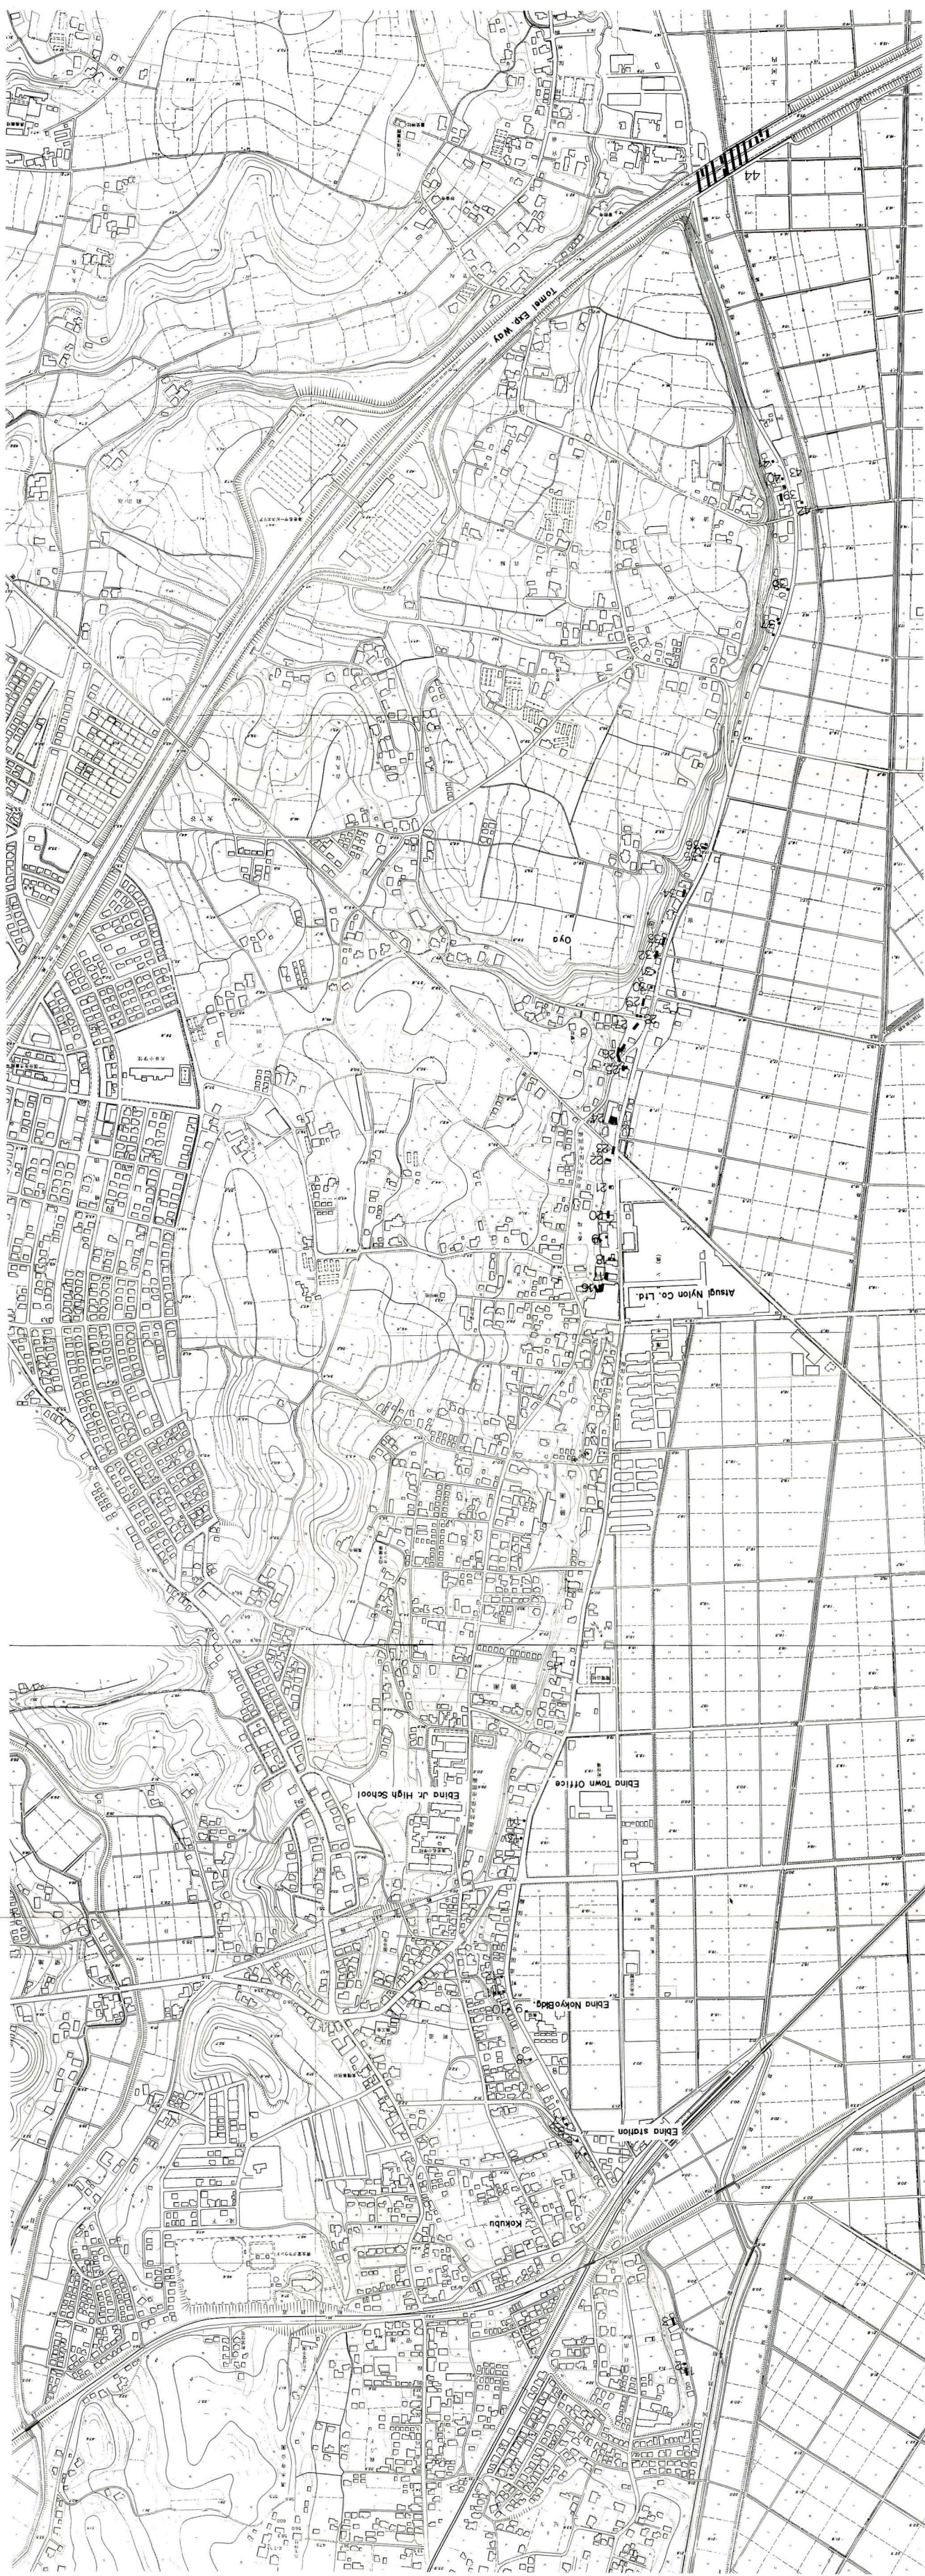
The distribution of ground cracks observed by the junior writer up to August 1970 is shown in Fig. 2. The information on individual cracks, such as their

Fig. 2. Map showing the distribution of ground cracks.
 The mark indicates the crack, the mark indicates the crack
 and its direction.

location, length, width, trend, mode of displacement, and distance from the road, Kokubu-Sugikubo Highway, running along the cliffs, have been measured at forty-four stations (Sites 1 to 44, Fig. 2), the results of which are listed in Table 1. Below is given some additional descriptions of them.

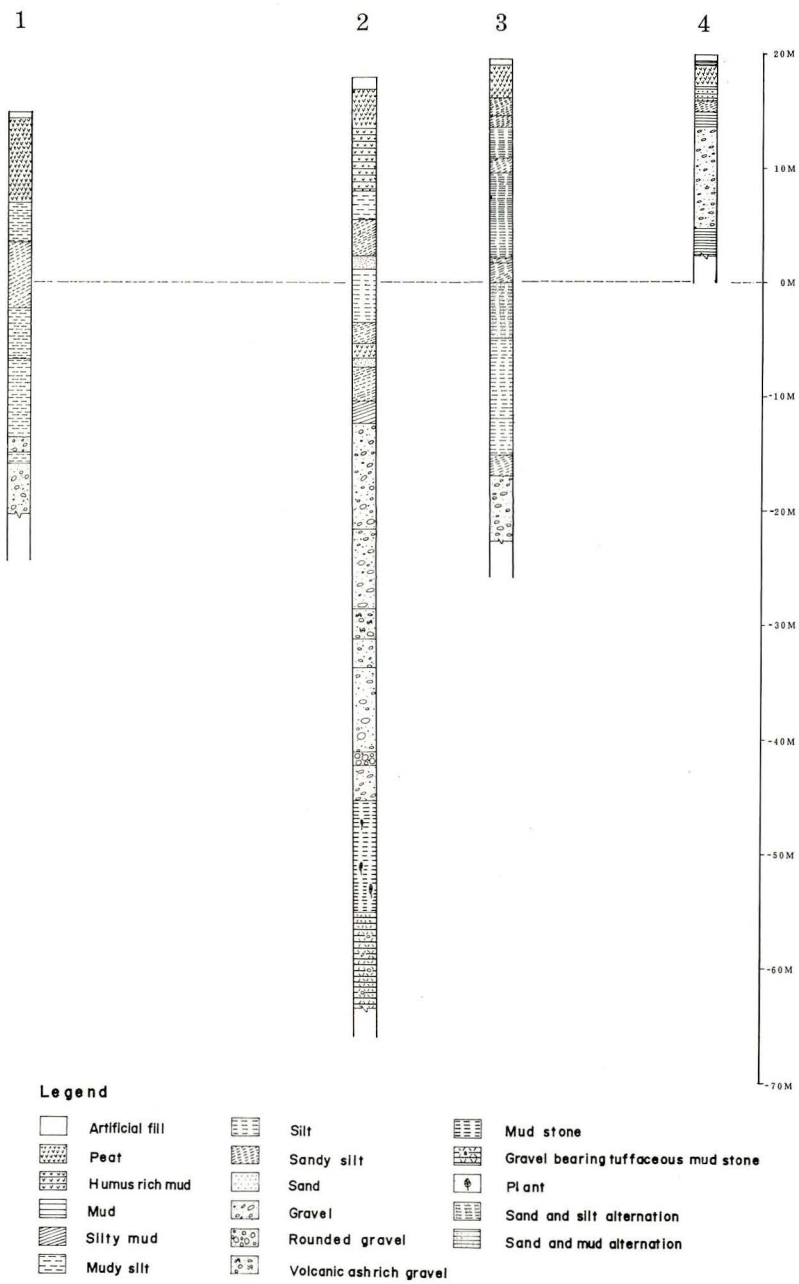
The back swamp consists mainly of humic soils and soft, unconsolidated muddy sediments overlying a gravel bed more than 30 m thick (Fig. 3).

Fig. 3. Columner section of the back swamp.

1. Tomei Exp. Way (about 50 m from the foot of cliff)
2. Test Bore Point
3. Atsugi Nylon Co., LTD.
4. Ebina Town Office
